Water Research Laboratory Memorandum

Subject: Conceptual Understanding and Prioritisation of Tuckean Swamp

WRL Ref: 2014129 M20181115

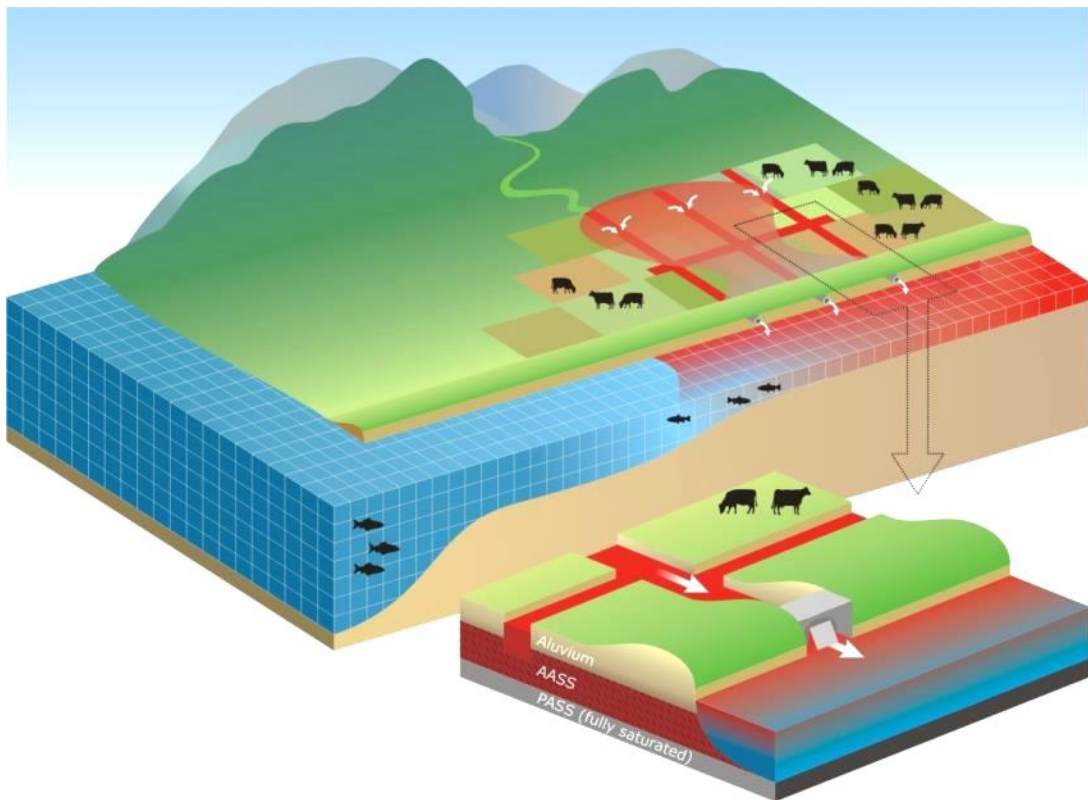
Figure 8 depicts the floodplain as the floodwaters recede. During this period, floodplain pastures are saturated and groundwater levels remain elevated, resulting in a steep gradient between drain water levels and the surrounding groundwater. This process mobilises acid from the soil towards drainage channels and downstream water bodies (see Figure 4). As the natural buffering capacity of the estuary has been removed by the fresh floodwaters, acidic plumes comprised of low pH water and high soluble metal concentration remain in the open estuary. In the Richmond River, large scale fish kills have been observed as a result of acid drainage from the Tuckean after significant rain events. These events have broad ranging ecological, environmental, social and economic implications on the broader estuary.

Figure 8: Period of Acid Impact Following Rainfall Event

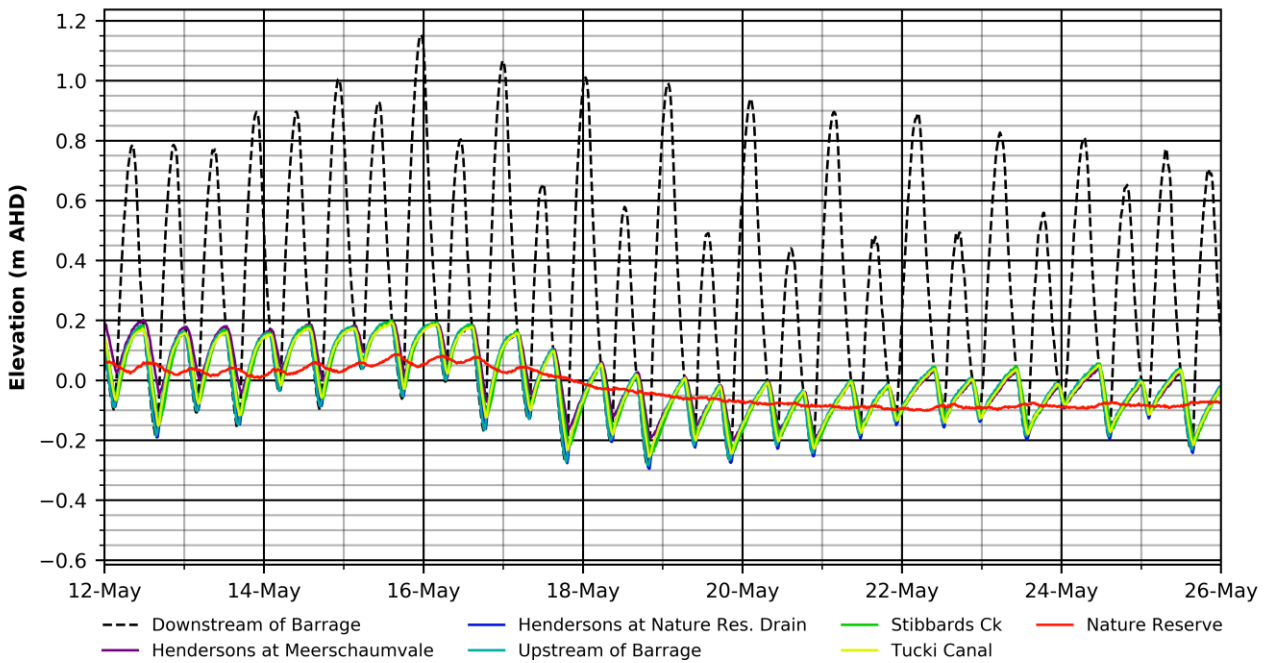
Figure 14: Observed water levels throughout May 12th – 26th

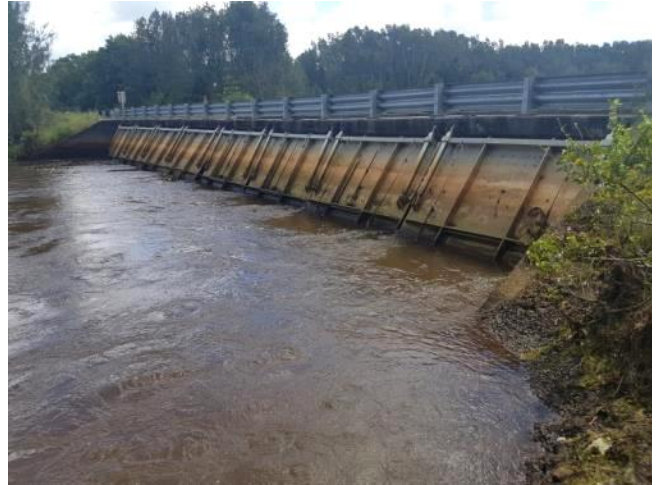
Area	Priority	Justification
		<ul style="list-style-type: none"> • High soil acidity observed at most profiles • Lower sections of Hendersons Drain are very deep (invert as low as -4 m AHD) • High flows (see image 2) • No aquatic life observed

2: Downstream Baggotville Barrage flowing out

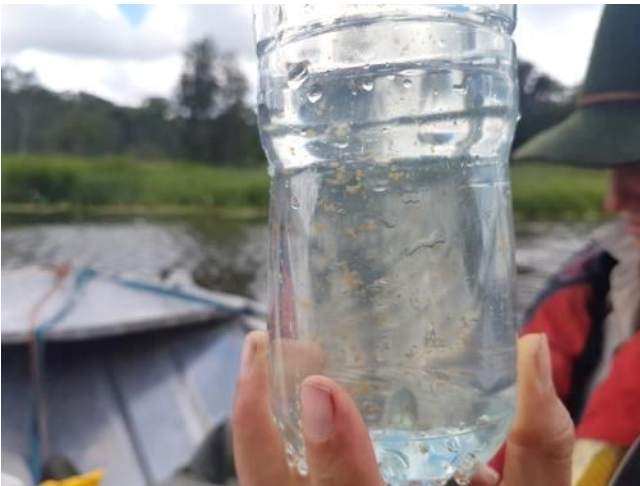
5. Lower Stibbards/ Lower Hendersons/ NPWS Area	High	<ul style="list-style-type: none"> • Lowest lying area of Tuckean Swamp, with significant area below 0 m AHD (mean sea level) • Surface water pH in Hendersons Drain was typically between 3 – 4 for the length of the Nature Reserve • Extensive iron staining observed in Hendersons Drain (see image 3, 4, 5 and 11) • Significant iron discharge observed in March 2018 (see image 3 and 4)

3: Iron floc in water sample, Hendersons Drain

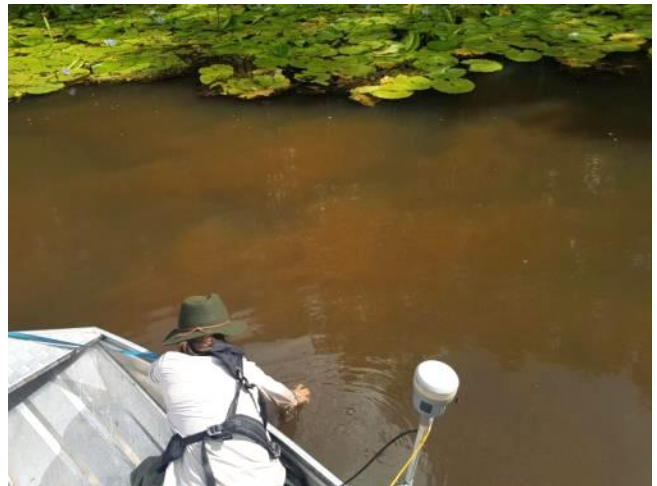
4: Extensive iron plumes, Hendersons Drain

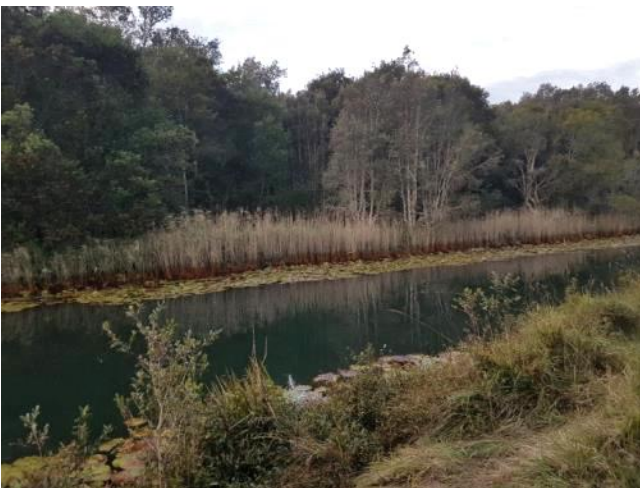
3. Nature Reserve Drain/ Central Hendersons/ NPWS Area	High	<ul style="list-style-type: none"> • Surface water pH in Hendersons Drain was typically between 3 – 4 for the length of the Nature Reserve • Extensive iron staining observed in Nature Reserve Drain and Hendersons Drain (see image 5) • Nature Reserve Drain appears to convey little flow during drier periods and appears to be infilling with soft sediments and other flow impediments (see image 12 and 23) • Low lying topography (see image 13) • No aquatic life observed

4. Tucki Canal/ Central Hendersons/ NPWS Area	High	<ul style="list-style-type: none"> • Surface water pH in Hendersons Drain was typically between 3 – 4 for the length of the Nature Reserve • Extensive iron staining observed in Hendersons Drain (however not in Tucki Canal) (see image 5) • High soil acidity observed at most profiles • Low lying topography • High catchment flows • No aquatic life observed

5: Iron staining on the banks of Hendersons Drain

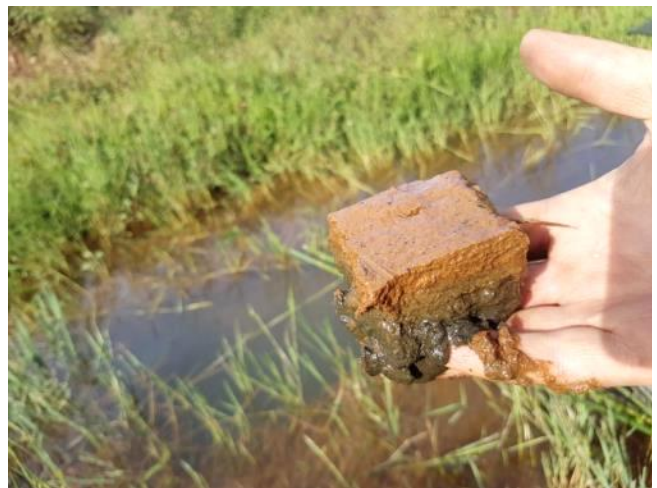
6: Settled iron in sediments, Hendersons Drain

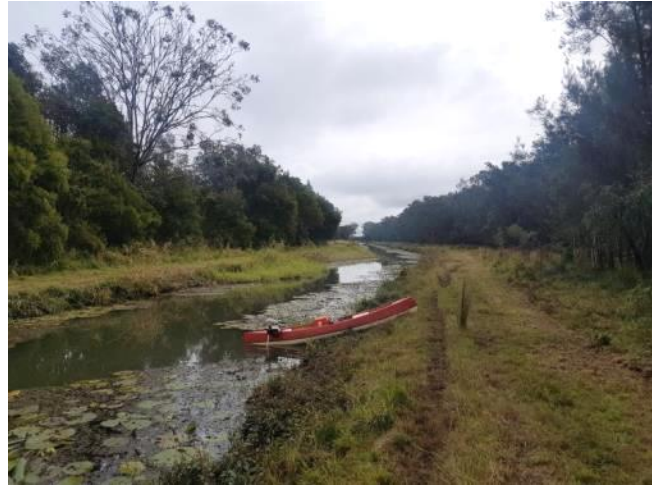
10. Stibbards Creek	Lowest	<ul style="list-style-type: none"> • Highest topography, with significant area above 1 m AHD • More natural creek line (see image 8) • Low hydraulic conductivity observed in dense clays (see image 9) • Near neutral surface water pH observed • Low soil acidity observed at available profiles • Smallest catchment inflows

8: Narrow, more natural alignment of Stibbards Creek

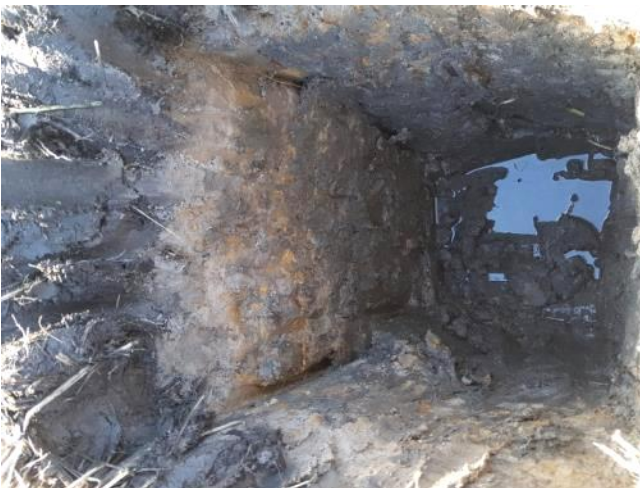
9: Dense clays with low hydraulic conductivity near Stibbards Creek

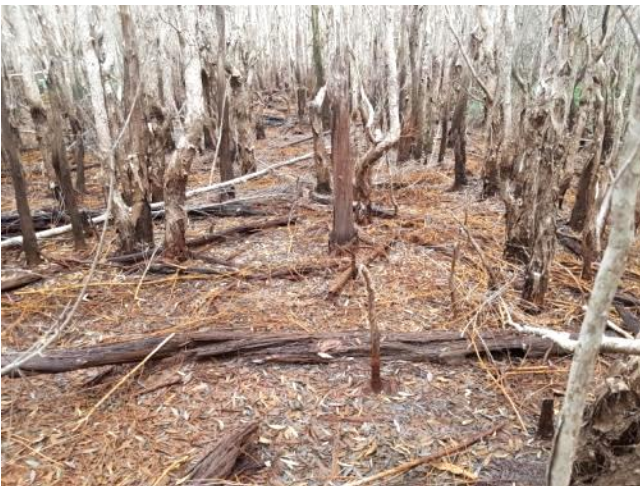
11: Iron staining throughout the Nature Reserve

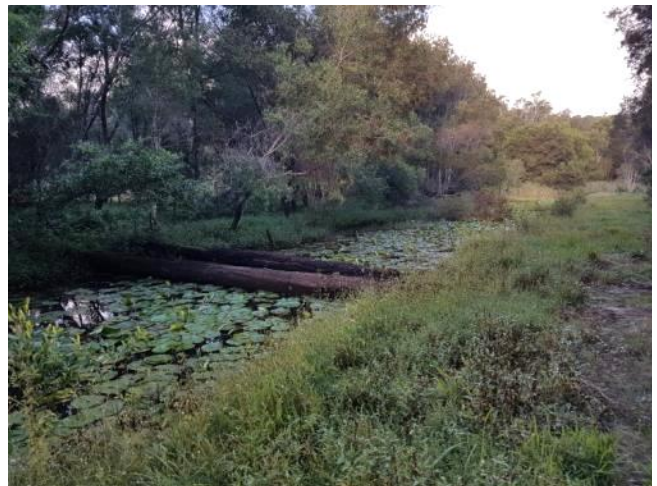
12: Significant blockages of Nature Reserve Drain

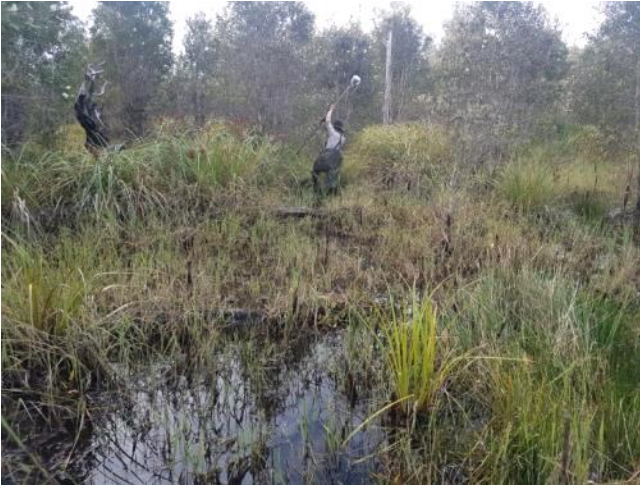
13: Extensive inundation of low lying area in Nature Reserve

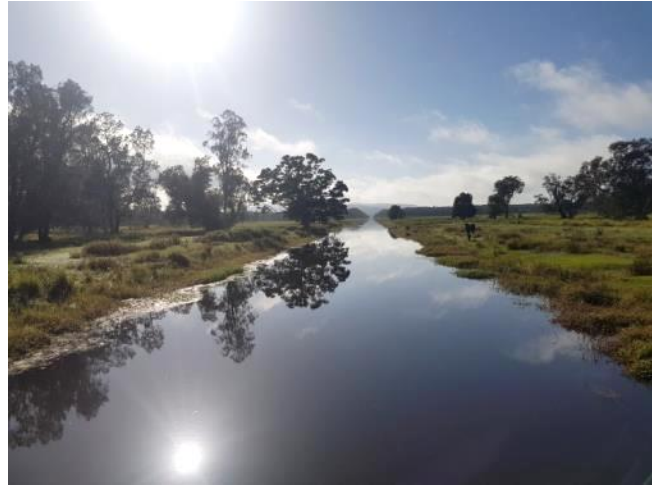
14: Wide, deep channel in Tucki Canal conveys most of the water from the north western section of Tuckean

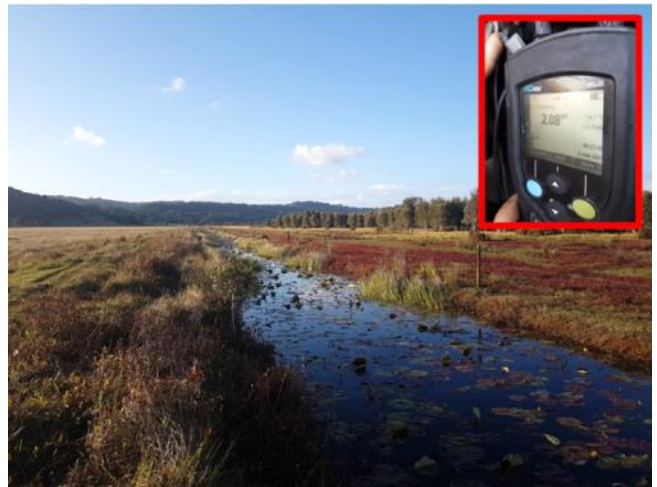
2. Meerschaum Vale/ Jumbo	Highest	<ul style="list-style-type: none"> • Worst surface acidity observed in 2018 in Jumbo Drain (pH of 2, approximately the same as a lemon) • High soil acidity observed at most profiles • Significant iron plumes observed discharging from Meerschaum Vale Drain into Hendersons Drain • Low lying topography, significant area between 0 – 0.2 m AHD (where 0 is approximately mean sea level) (see image 16 and 19) • No aquatic life observed

16: Jumbo Drain, where pH comparable to lemon juice (pH=2) was observed

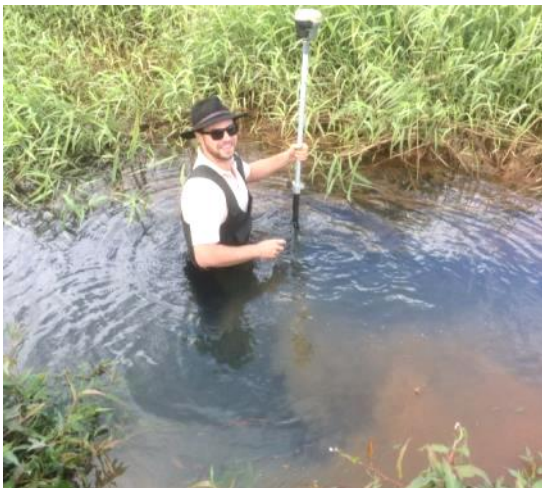
Area	Priority	Justification
1. Upper Slatteries	Highest	<ul style="list-style-type: none"> • Large catchment flows • High soil acidity observed • Acidic surface waters observed, particularly at the confluence with Meerschaum Vale Drain • No aquatic life observed • Significant iron floc settlement observed (see image 17) • Low lying topography (see image 20)

17: Narrowing of Slatteries Drain with significant iron floc settled on bed and banks

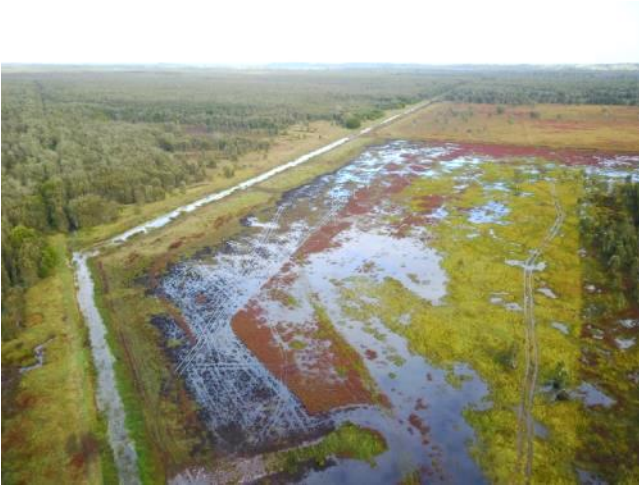
19: Low lying land inundation at the confluence of Slatteries and Meerscham Vale Drain

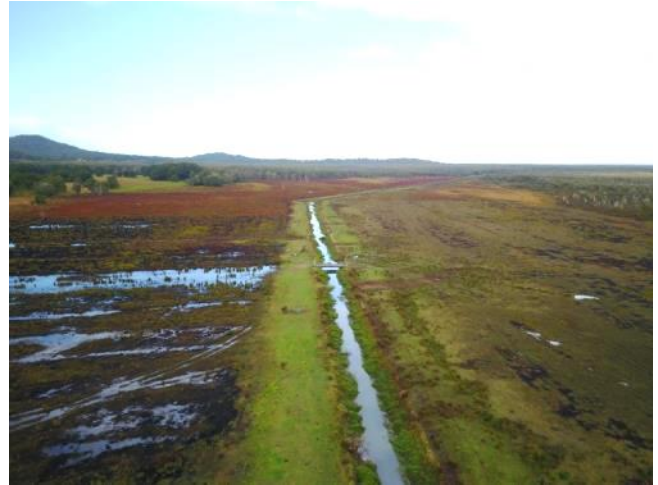
20: Looking downstream along Slatteries Drain

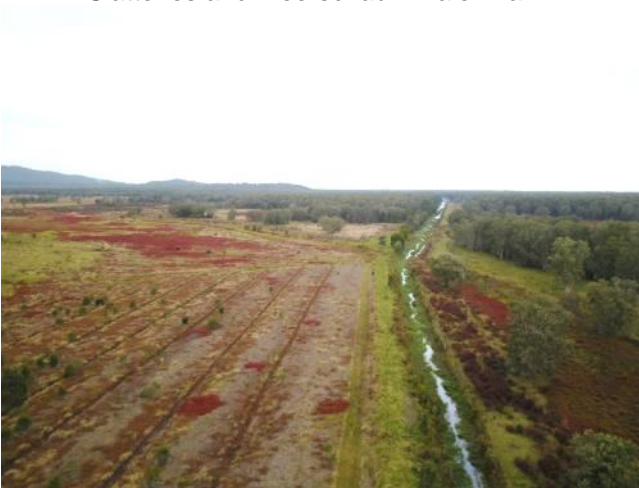
6. Upper Hendersons/ Marom Creek	Moderate	<ul style="list-style-type: none"> • Cross sections surveyed of Hendersons Drain in the lower portion of this section is deep (drain invert around -1.5 m AHD), but narrow (see image 21) • Most of the area is below 1 m AHD • Some poor surface water quality observed in minor drains • Smaller catchment inflows • High soil acidity observed at some profiles

21: Hendersons Drain, looking downstream.
